Lessons Learnt From the 2009 Padang Indonesia, 2011 Tohoku Japan and 2016 Muisne Ecuador Earthquakes

Article in *Frontiers in Built Environment* · June 2019

This paper presents the observations during the UK Earthquake Engineering Field Investigation Team (EEFIT)'s post-earthquake reconnaissance missions to the September 20, 2009 Padang (M_w 7.6), March 11, 2011 Tōhoku (M_w 9.0) and April 16, 2016 Muisne (M_w 7.8) earthquakes. The performance of buildings and geotechnical structures within the affected regions were investigated to gain insights on their design and construction deficiencies. Findings on these damages observed are compared along with the characteristics of the earthquake and nature of building codes in these countries. They include building damages attributed to a combination of structural resonance, deficiencies in reinforcement detailing, vulnerability to soft story collapse, ground settlement, soil liquefaction, and landslides. It was demonstrated that buildings which were severely damaged had natural building frequencies coinciding with the dominant frequencies of the ground shaking. The locations of damage of several such buildings showed insufficient confinin

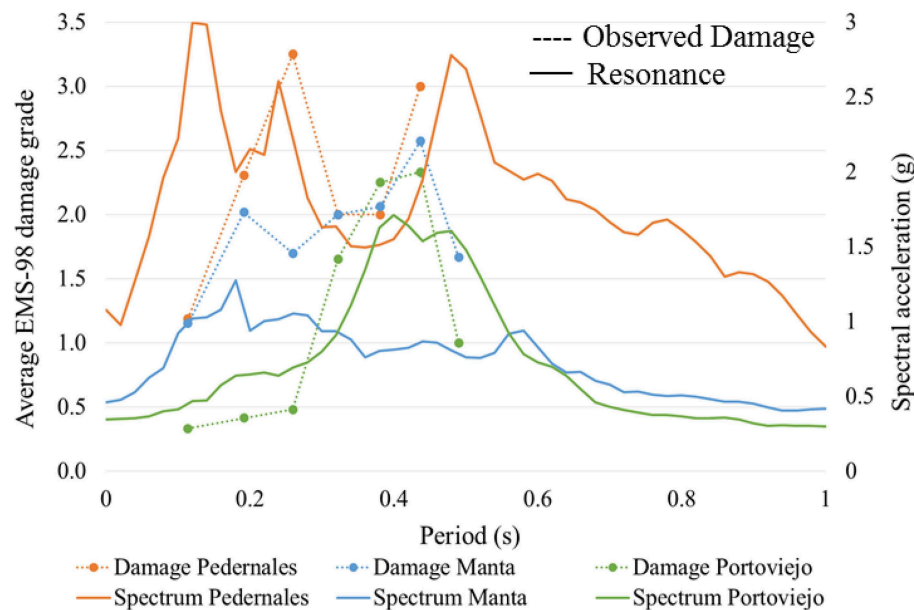
Figure 10 compares the spectral accelerations recorded at stations in Pedernales, Manta, and Portoviejo, with the average damage grades of RC and timber/bamboo structures of different fundamental periods estimated based on their typology and height. It can be observed that higher grades of damage generally coincide with higher spectral acceleration of the shaking in

Pedernales, Manta and Portoviejo at similar periods. This confirms damage attributed to structural resonance which is in line with findings in Padang and Tōhoku earthquakes. Significant damage was observed for two- to five-story buildings at Pedernales which coincides with the dominant periods of 0.2 and 0.5 s. Similarly, two- to four-stories were observed to be most heavily damaged at Manta and Portoviejo, respectively which coincides with young Quaternary sediments according to the geological map in **Figure 3B**. In contrast, high-rise buildings >10 stories were most affected at Chone where dominant shaking period was 1.3 s. It is worth noting that earlier versions of the seismic code in Ecuador (e.g., Código de Práctica Ecuatoriano, 2001; CPE INEN 5:2001) were based on US seismic codes of the time (e.g., Uniform Building Code, 1997). The latest version has been updated in recent years (Norma Ecuatoriana de la Construcción, 2015), maintaining however the manner in which seismic actions are derived. Microtremor recording using a TROMINO Zero[®] instrument, non-invasive, passive geophysical method, was conducted at several locations in Manta, Portoviejo, Pedernales, and Bahia to ascertain the fundamental frequency and shear wave velocity profiles for each site for site response analysis. The method is based on measuring ambient seismic noise and translating it through time domain

FIGURE 10 | Relationship between response spectra from recorded ground motions and surveyed building damaged (Franco et al., 2017).

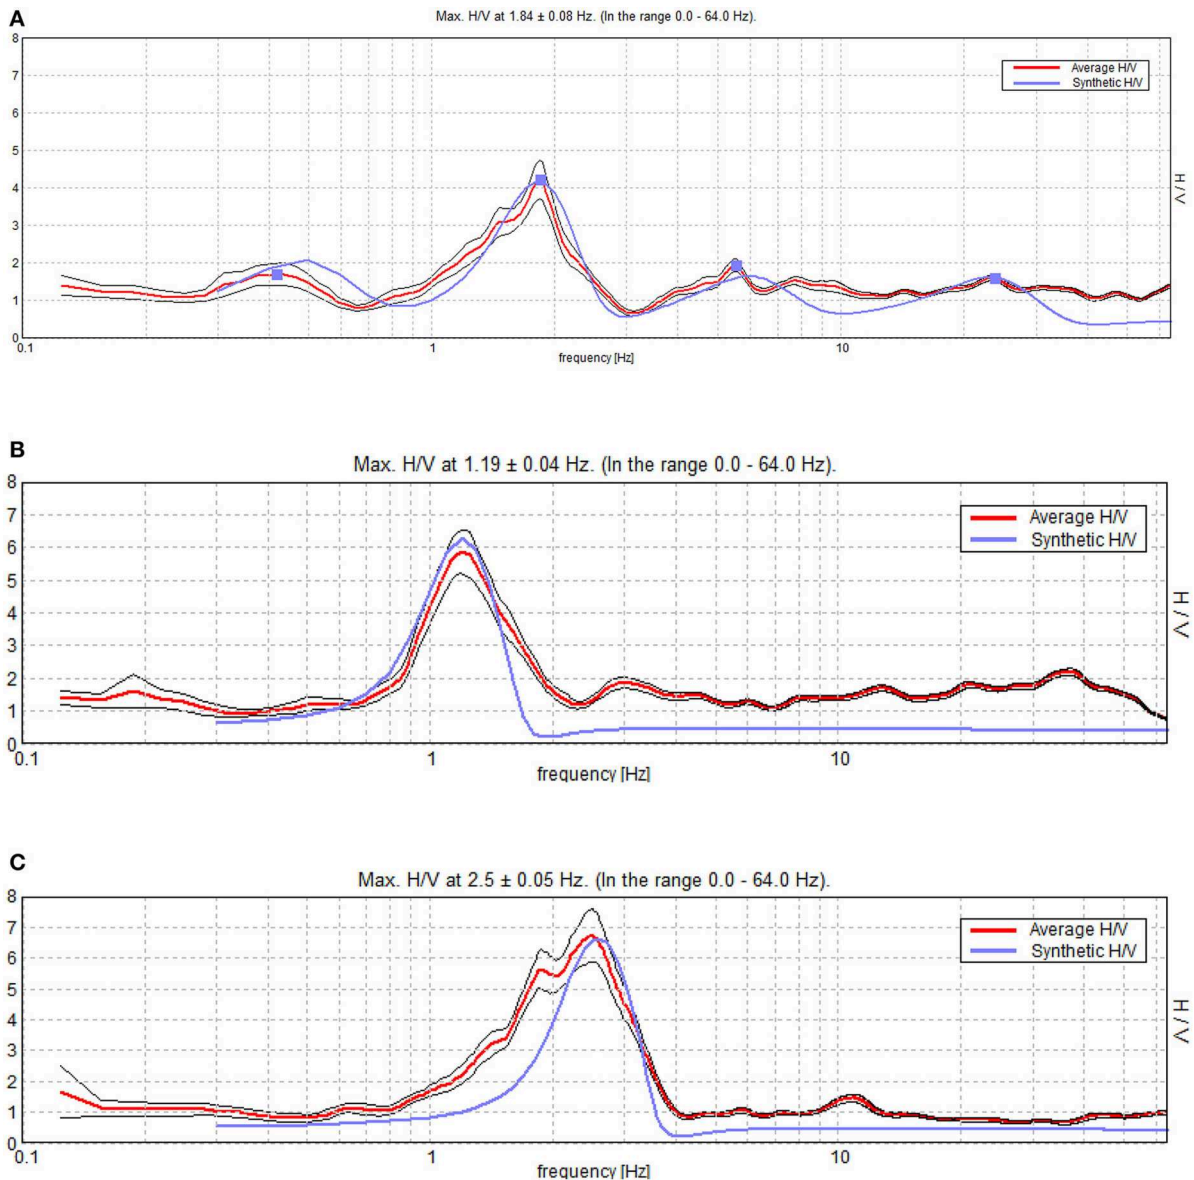
and spectral techniques (Nakamura, 1989). Measurements were taken close to the locations of strong ground recording stations installed by the Instituto Geofísico in Pedernales and Portoviejo. **Figure 11** shows the comparison of the H/V ratio measurement and shear wave velocity profile at Manta, Portoviejo and Pedernales. Further details of the microtremor analysis can be found in the reconnaissance report [Earthquake Engineering Field Investigation Team (EEFIT), 2016].

FIGURE 11 | H/V ratio measurements and derived spectrum from *in situ* shear wave velocity at various sites in Ecuador. **(A)** Tarqui, Manta. **(B)** River Bank, Portoviejo. **(C)** Seismic measuring station APED, Pedernales.

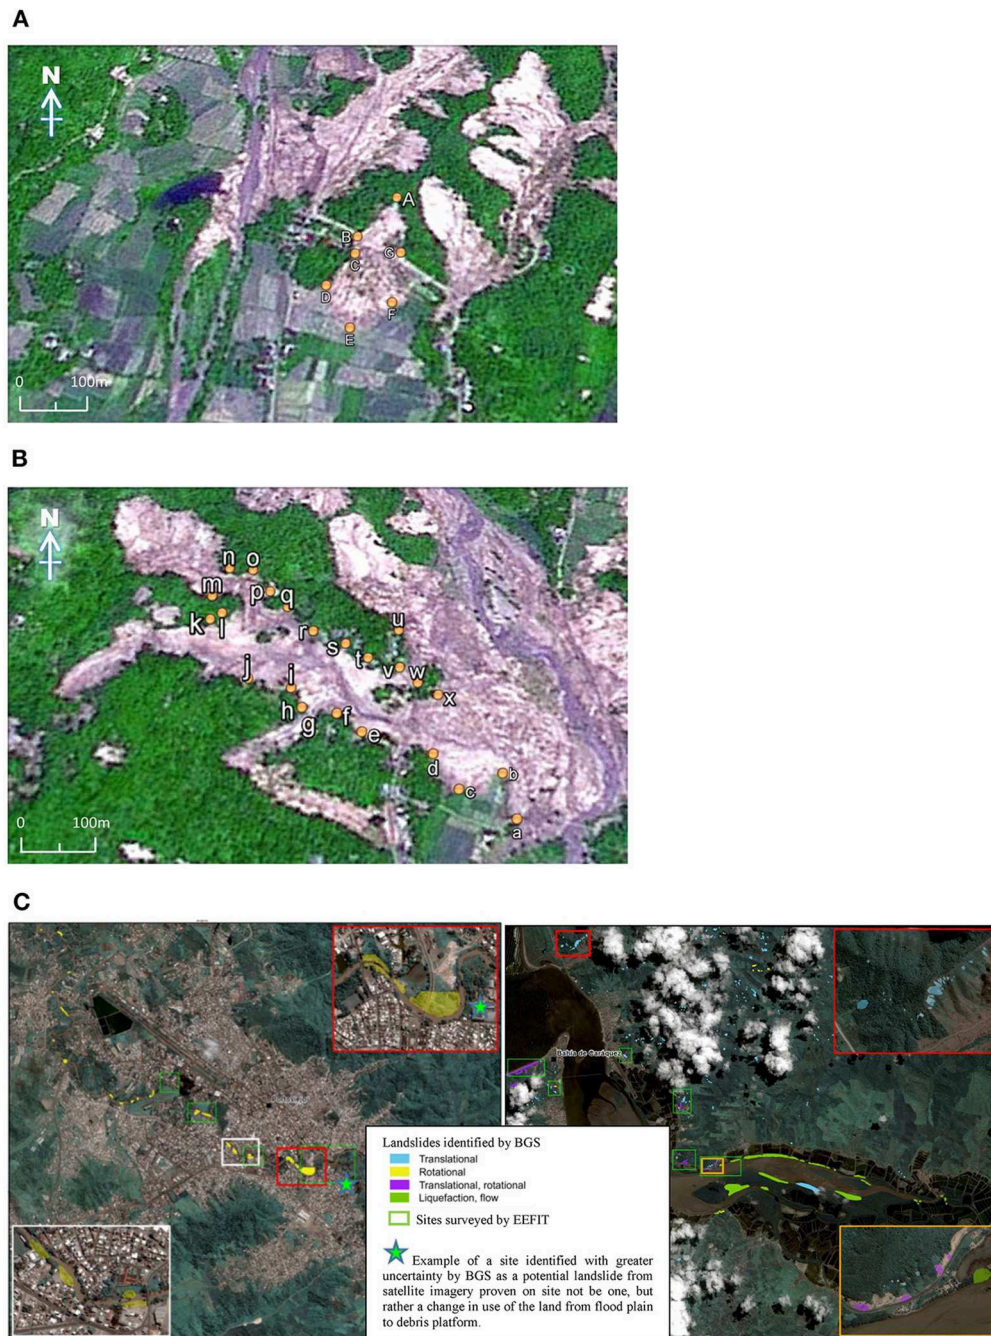
FIGURE 15 | Landslides in Sumatra and Ecuador identified from satellite imagery. **(A)** Locations of Landslide I boundary points at Pariaman, superimposed on SPOT-5 satellite image, acquired by Center for Remote Imaging, Sensing and Processing, National University of Singapore. **(B)** Locations of Landslide II boundary points at Pariaman, superimposed on SPOT-5 satellite image, acquired by Center for Remote Imaging, Sensing and Processing, National University of Singapore. **(C)** Landslide in Ecuador identified from satellite imagery, left: Portoviejo; right: Bahia de Caraquez (British Geological Survey, 2016a,b).

90 m in spatial resolution. Landslide *I* (a small landslide at Pulau Air Village, **Figure 15A**) and Landslide *II* (a large scale landslide at Cumanak Village, **Figure 15B**) were selected to: (1) assess repeatability between different data sources, (2) ascertain any influence the size of landslide may have on the deviation
